Warburton Mountain Bike Trail  
Environmental Effects Statement Technical Report  
Aboriginal and historic heritage

Prepared for AECOM

31 August 2021

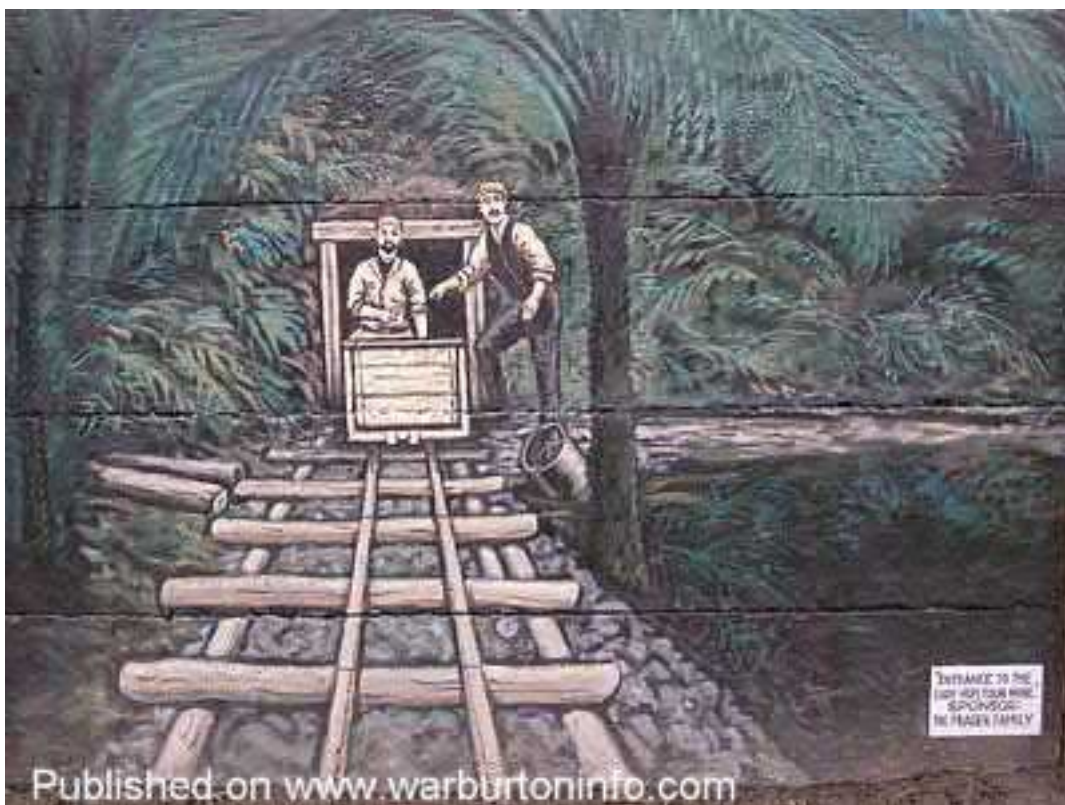
**Plate 6 Lady Hopetoun Mine (Station Mural from photograph)**

The Lady Hopetoun Mine (Plate 6) was established in about 1889, when W Wye found gold at the head of Scotchman's Creek and formed a small company called the Lady Hopetoun gold Mining Company which was managed by Mr W Murphy. They initially drove a tunnel into the hill side and flowed this with another 75 feet lower down, and erected a 10 head battery, which was run by water from the 'old water race' which they cleaned out ('GOLD-MINING AT WARBURTON', 1891). The mine had to cut through granite boulders to reach the dyke 5 feet wide, while the cost of the race was put at £10,000. However, in October 1890 the shareholders met to consider winding the company up (Anon. 1890).

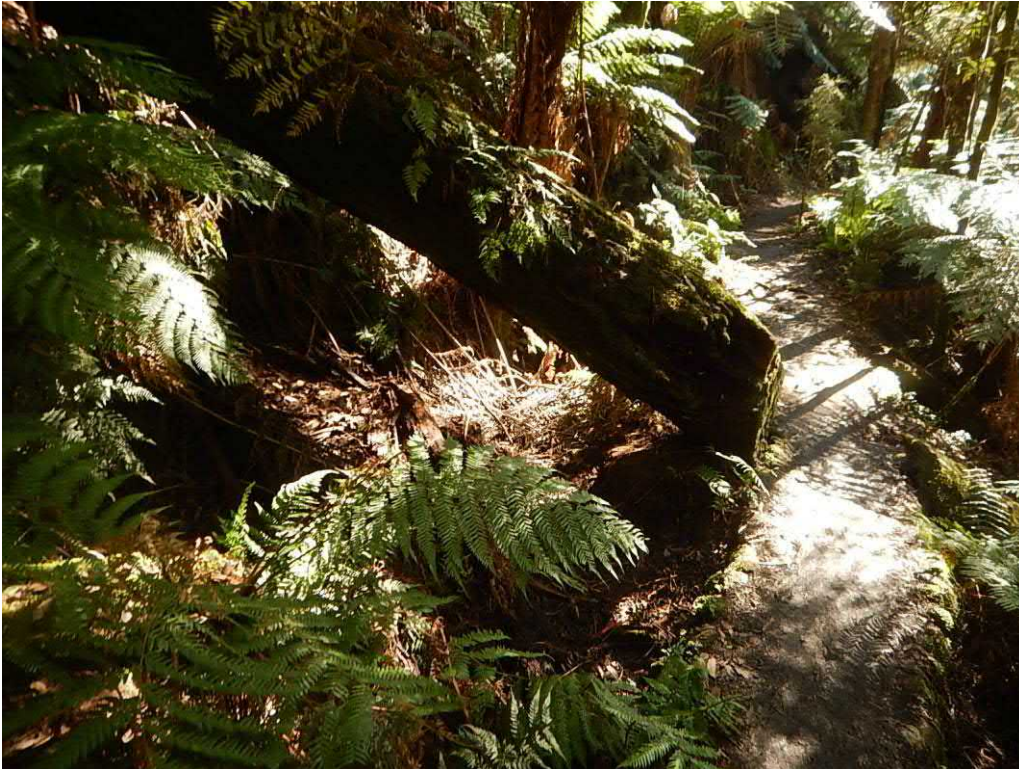
**Plate 22 La La Falls track crossing remains of Yankee Jim water race. (G.Vines 30/4/2021)**

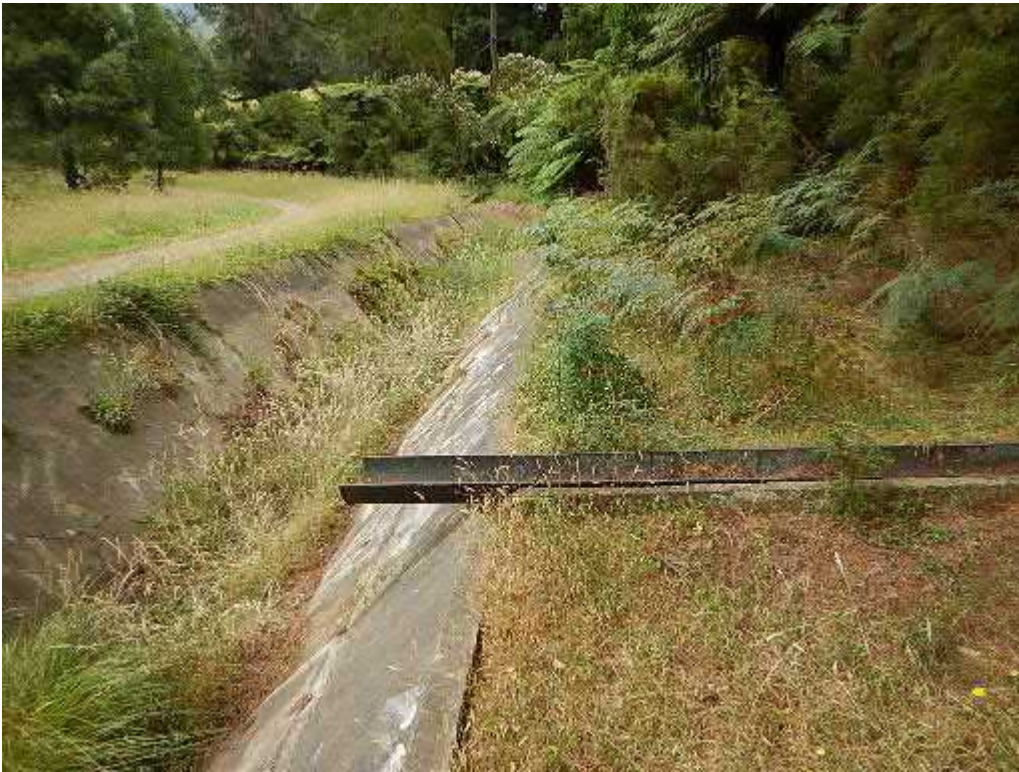
**Plate 24** Surface diversion channel at O'Shannassy aqueduct (G.Vines 16/01/2019)

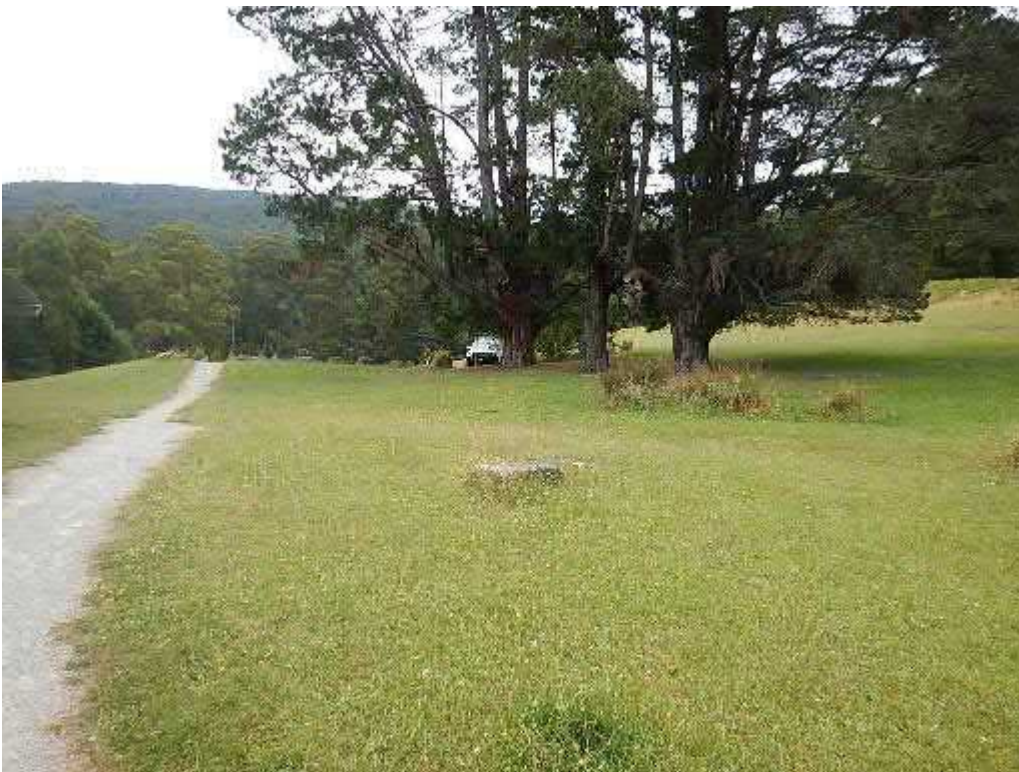
**Plate 25** Concrete block at O'Shannassy Aqueduct car park (G.Vines 16/01/2019)

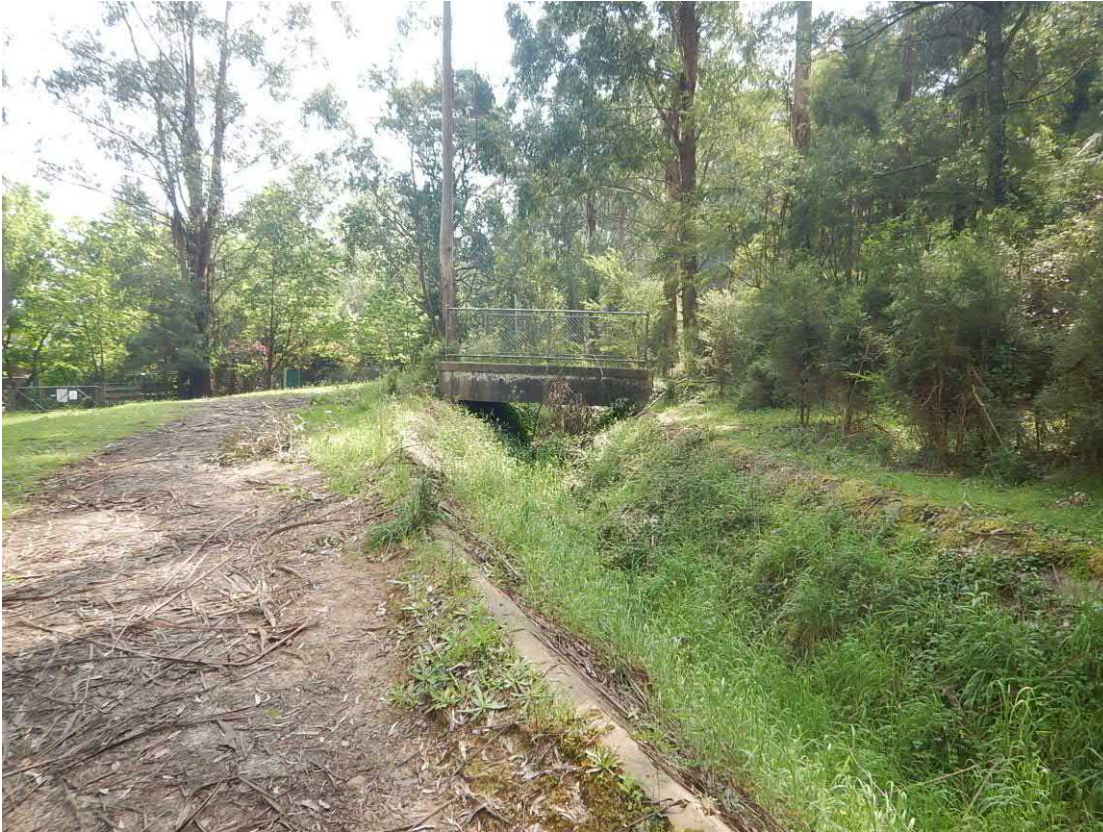
**Plate 26 Concrete bridge over O'Shannassy Aqueduct at Andersons Tramway crossing (G.Vines 1/11/2019)**

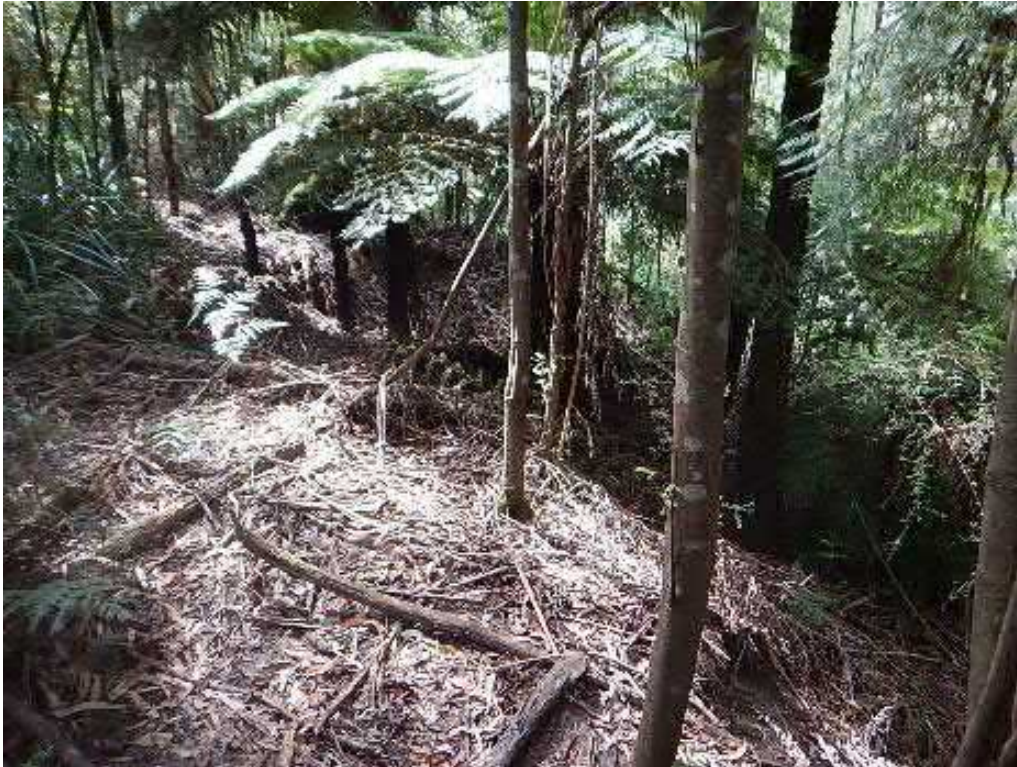
**Plate 27** Mining bench near Backstairs Creek (G.Vines 15/01/2019)

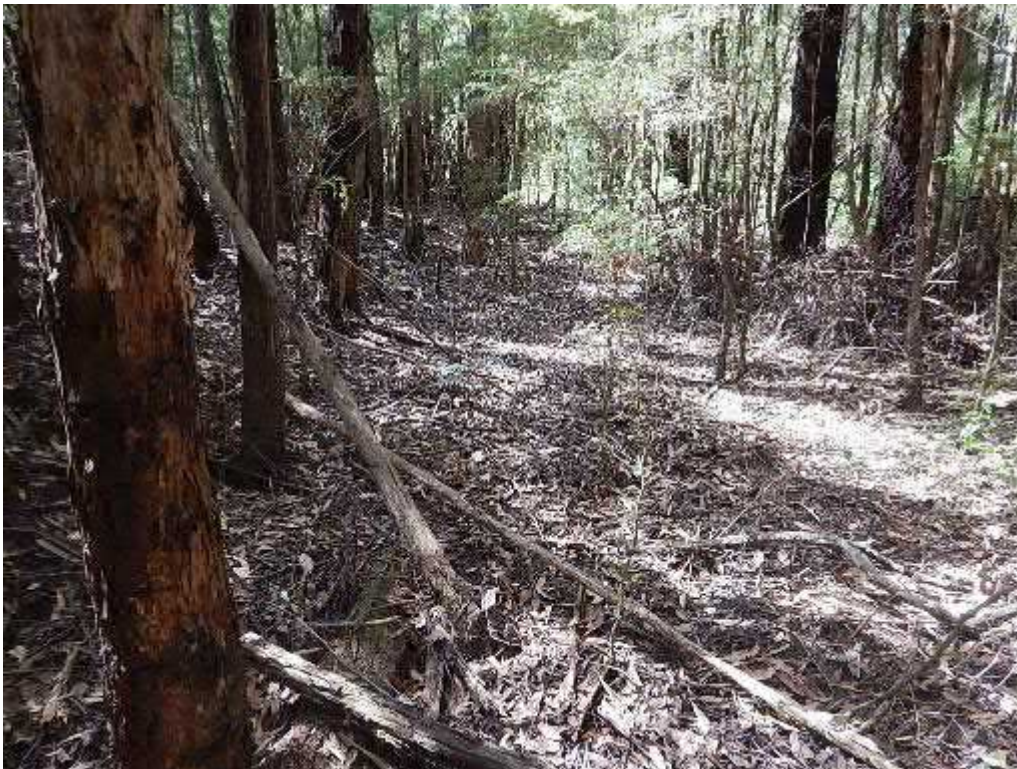
**Plate 28** Tramway formation near Yankee Jim Creek along the east side of the Old Warburton Cemetery Reserve (G.Vines 15/01/2019)

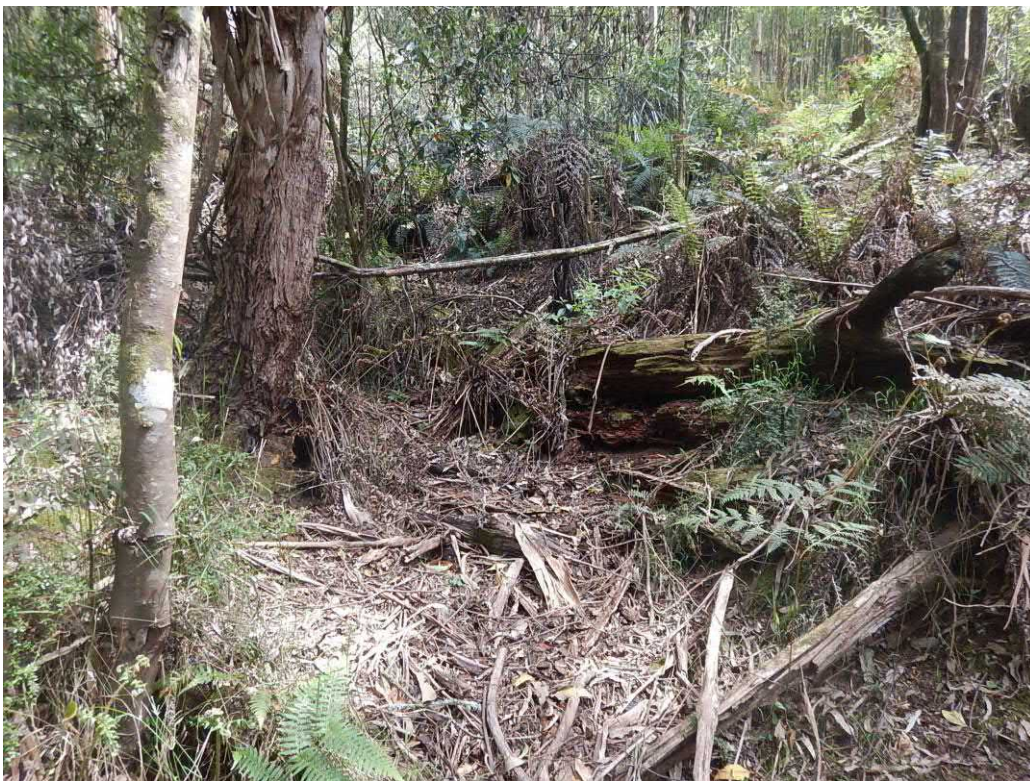
**Plate 29** Looking towards collapsed adit at Lady Hopetoun Mine (compare with Plate 6)

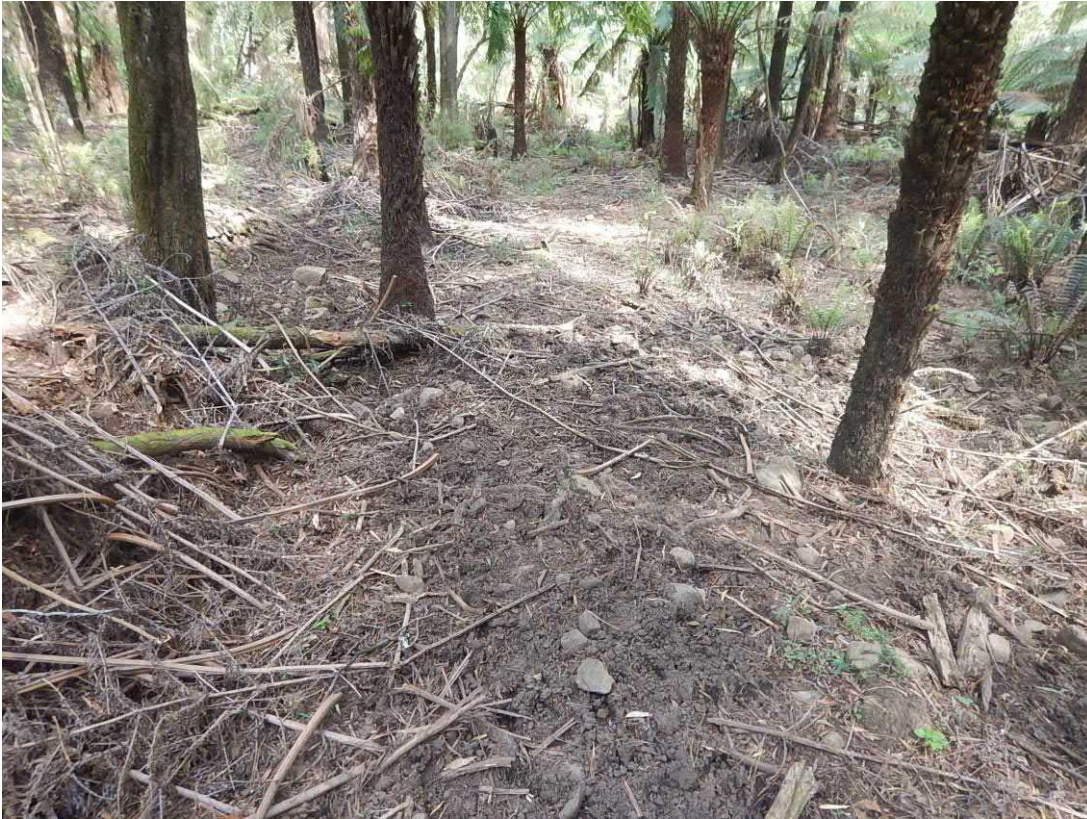
**Plate 32** Alignment of Anderson / Parbury tramway looking south from near aqueduct (G.Vines 1/11/2019)

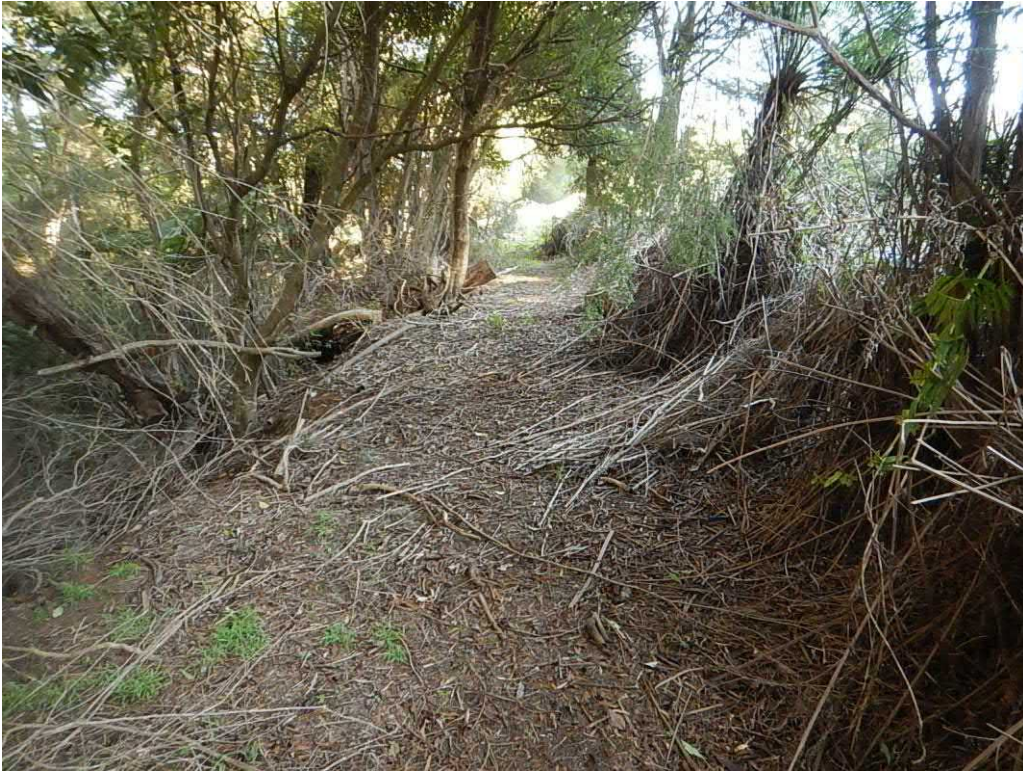
**Plate 34** Section of Andersons Tramway within golf course (G.Vines 30/4/2021)

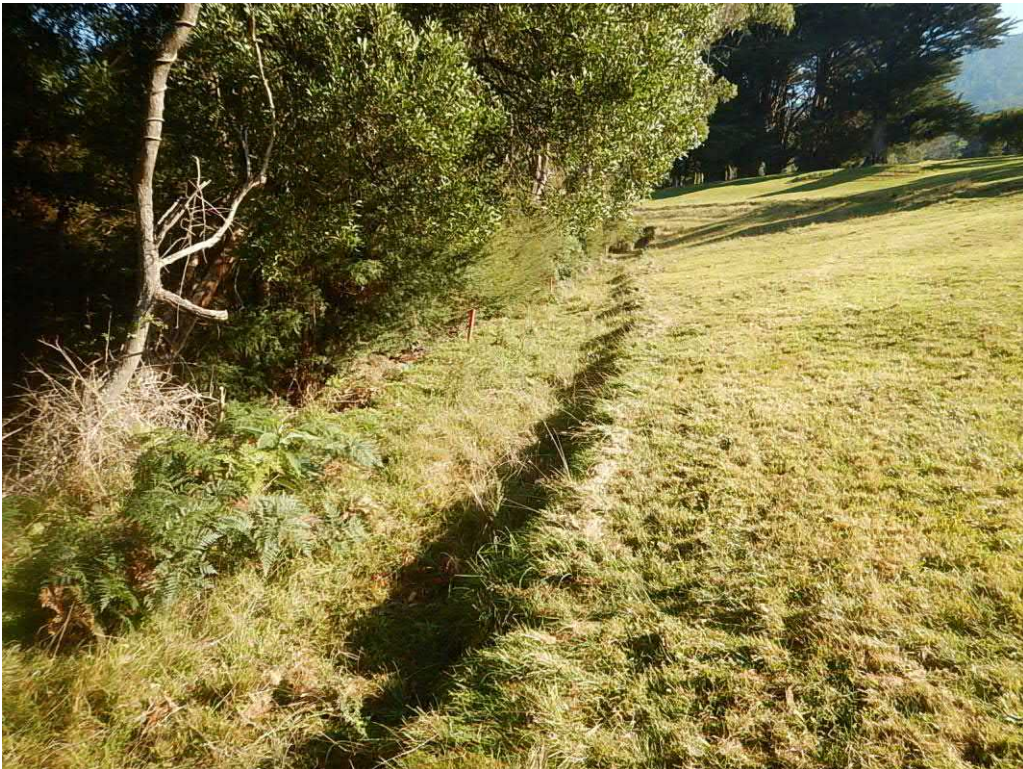
**Plate 35** Section of Andersons Tramway within golf course (G.Vines 30/4/2021)

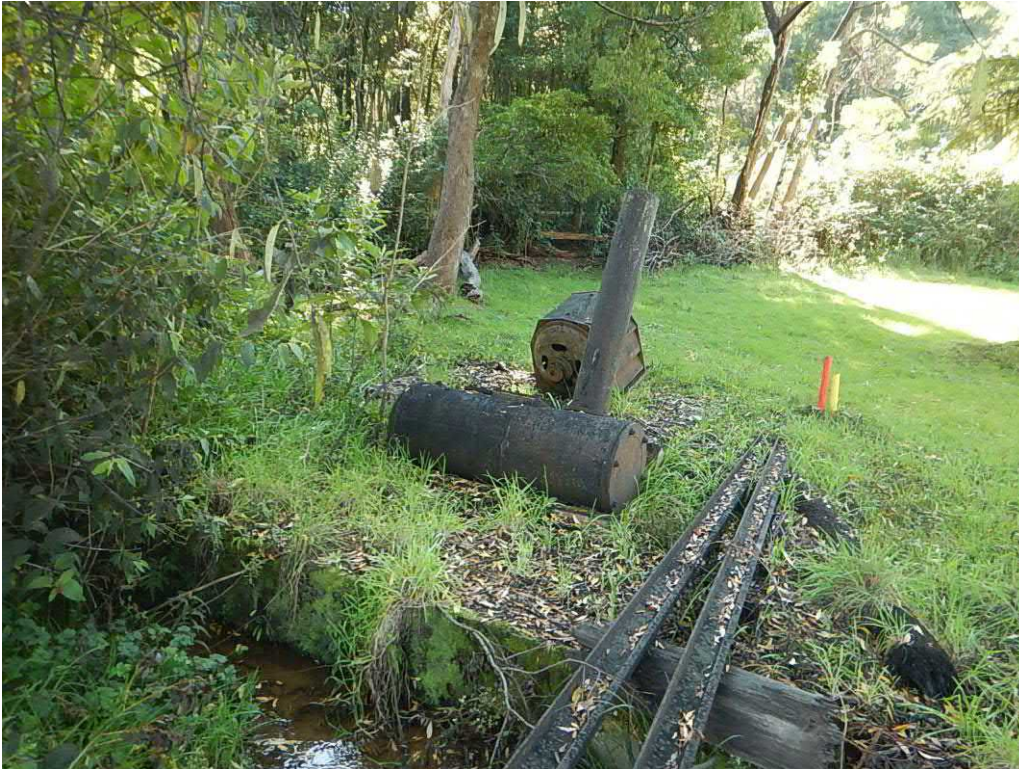
**Plate 36 Machinery and concrete foundations from Anderson's and Parbury's mill on the golf course (G.Vines 30/4/2021)**

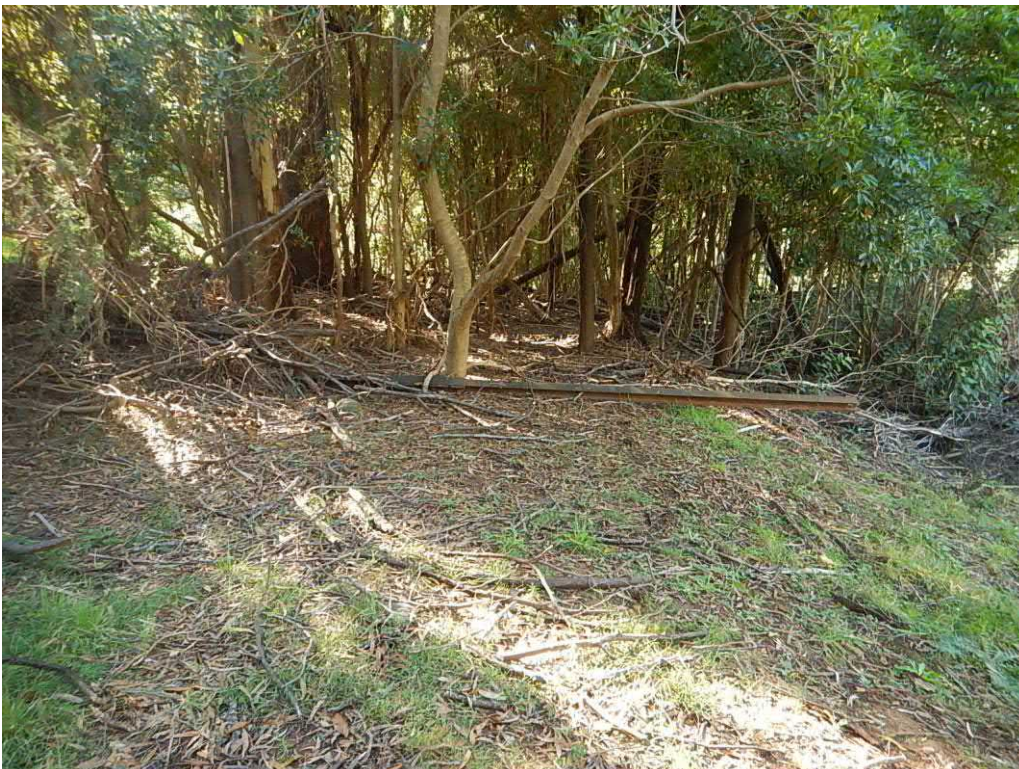
**Plate 37 Section of rail and level platform at Andersons mill (G.Vines 30/4/2021)**
